**Jefferson Proving Ground  
South of the Firing Line**

**Final Asbestos Survey Summary Report**

**Volume III  
(Buildings 230 through 475)**

**September 1993**

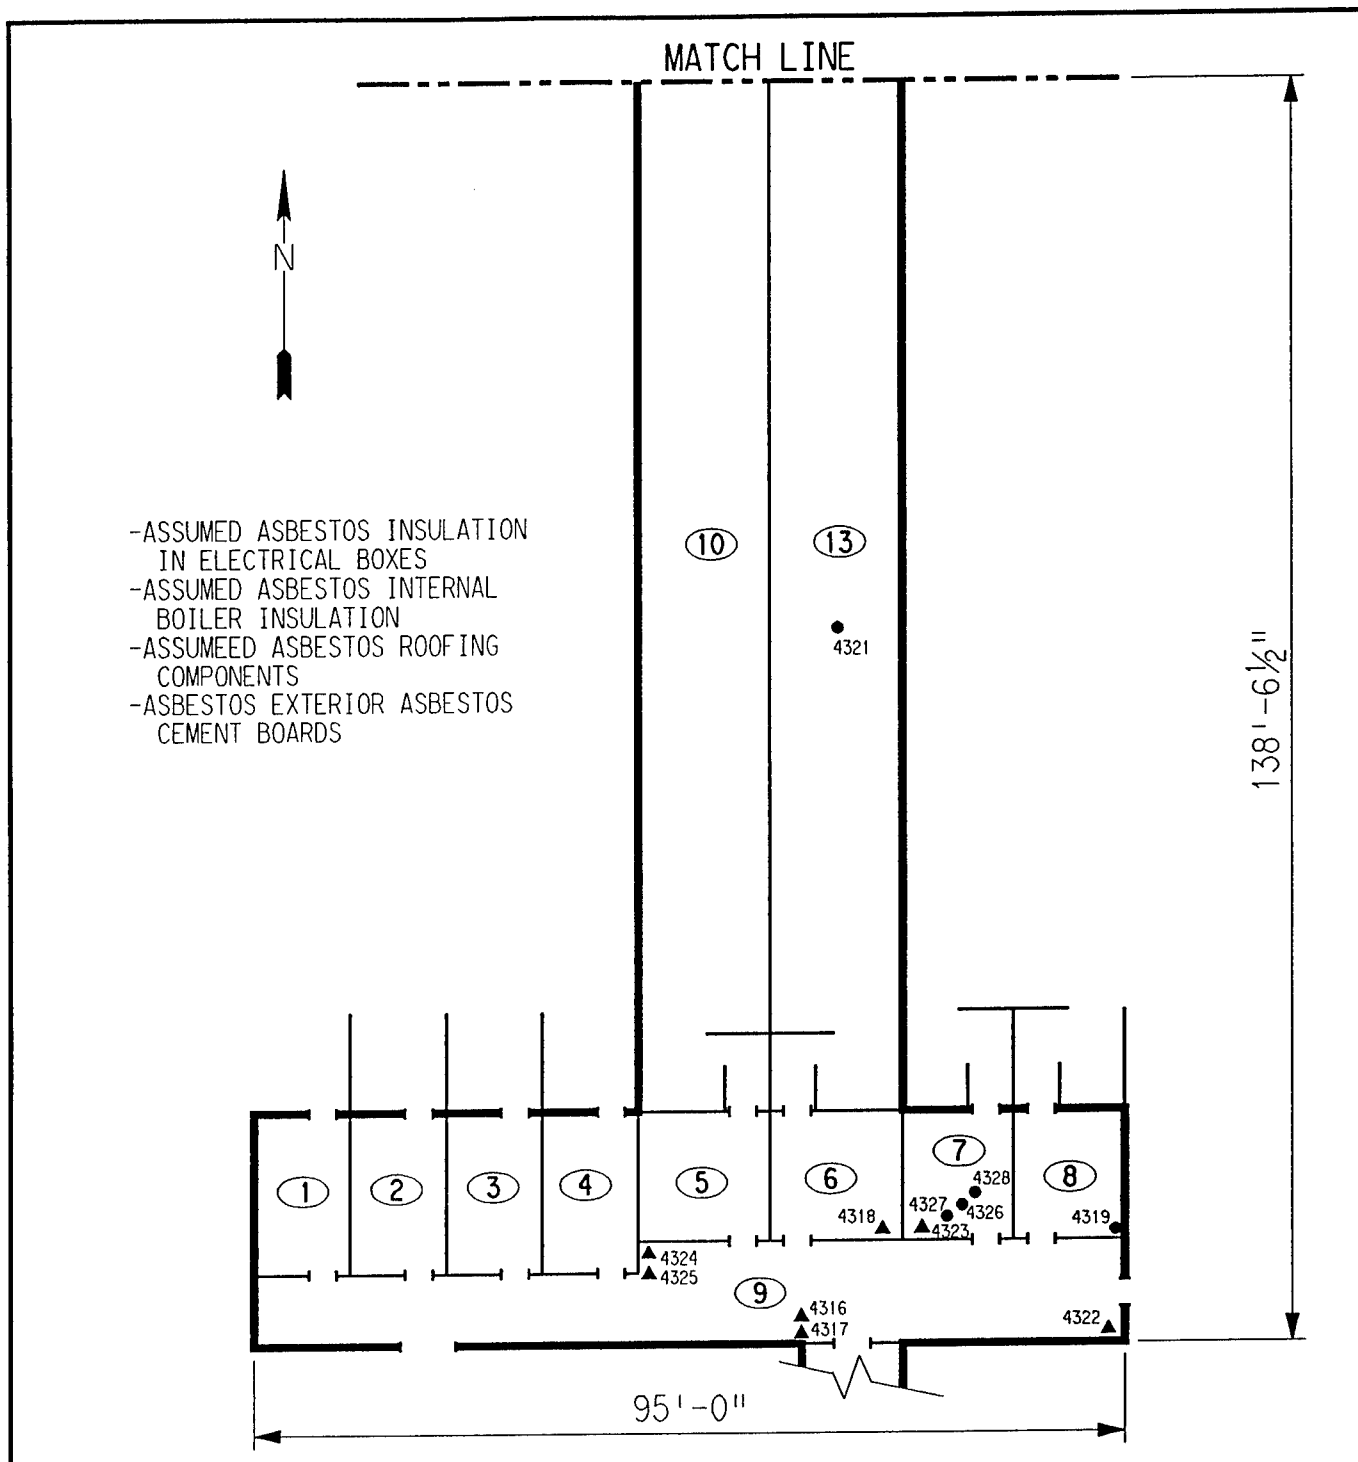
The general condition of ACM present was observed to be fair to good as noted above. Pipe insulations were observed to be friable, while other ACMs were nonfriable.

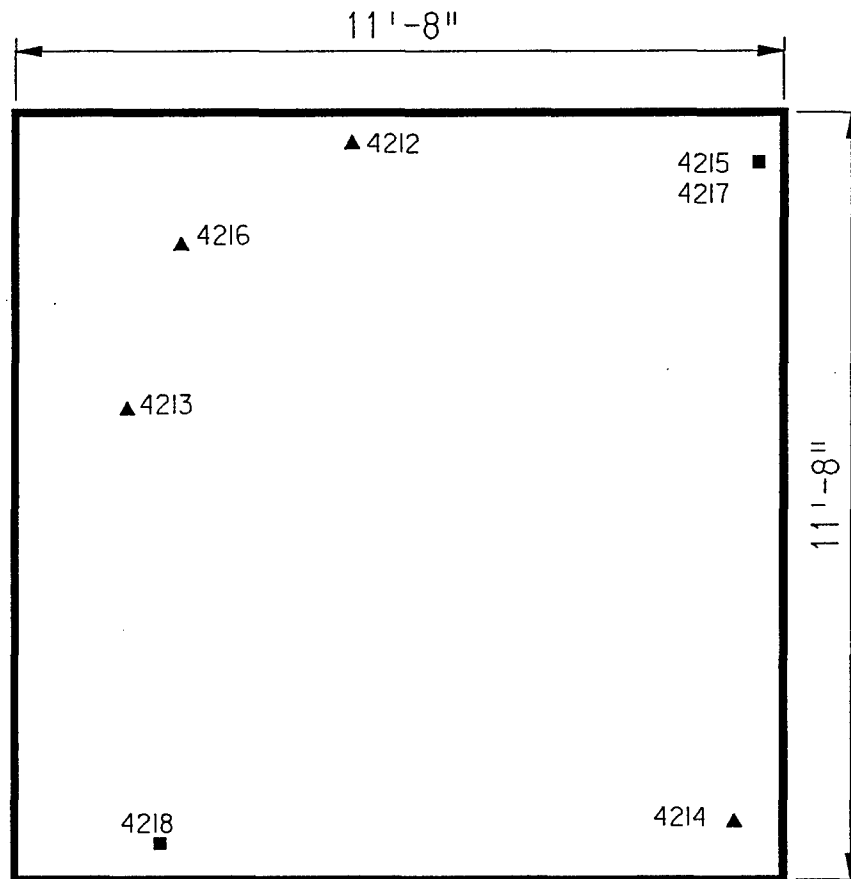
- #1 Entire Structure: **ACM Assessment Rating D**, the friable ACM is in good condition in an unoccupied area.

The general condition of ACM was good with exceptions noted above. ACM pipe insulations were friable, while the remaining ACMs were nonfriable.

The "ACM Assessment Checklist" (Short Forms and Key), shown on page 19, provides an example of how the assessment rating was tabulated from the damage and exposure assessments. An ACM assessment rating of D calls for repair and initiation of a special O&M program. Damaged areas should be repaired, where "repair" means returning damaged ACM to an undamaged condition to contain fiber release.

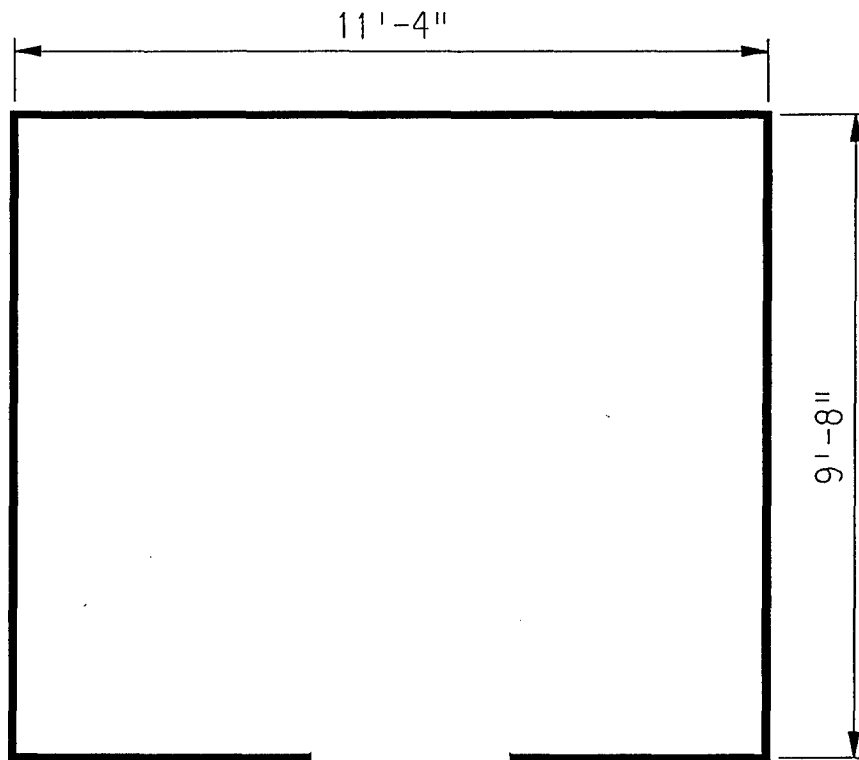
The general condition of ACM present was observed to be good with the noted exceptions above. ACM observed was nonfriable.

ASSUMED ASBESTOS ELECTRICAL PANEL INSULATION

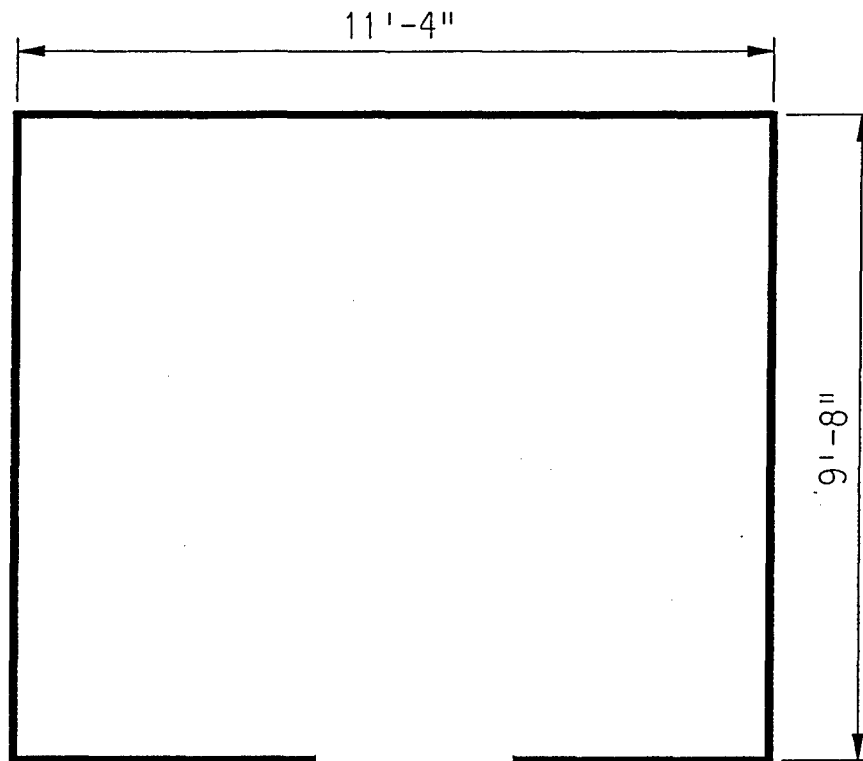
The general condition of ACM present was observed to be good with the noted exceptions above. ACM observed was nonfriable.

ASSUMED ASBESTOS ELECTRICAL PANEL INSULATION

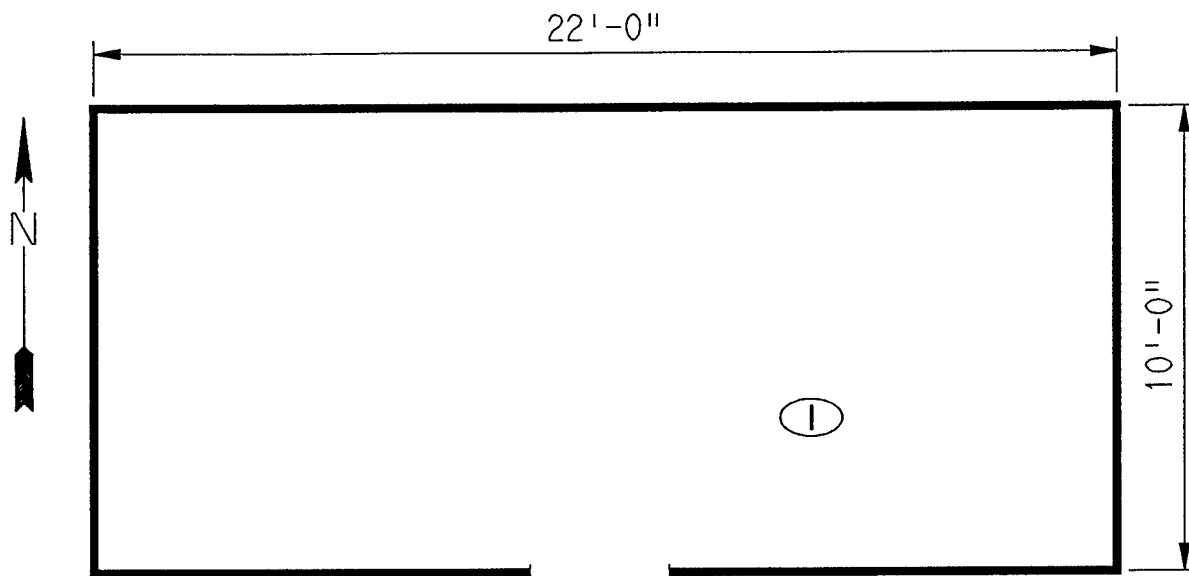
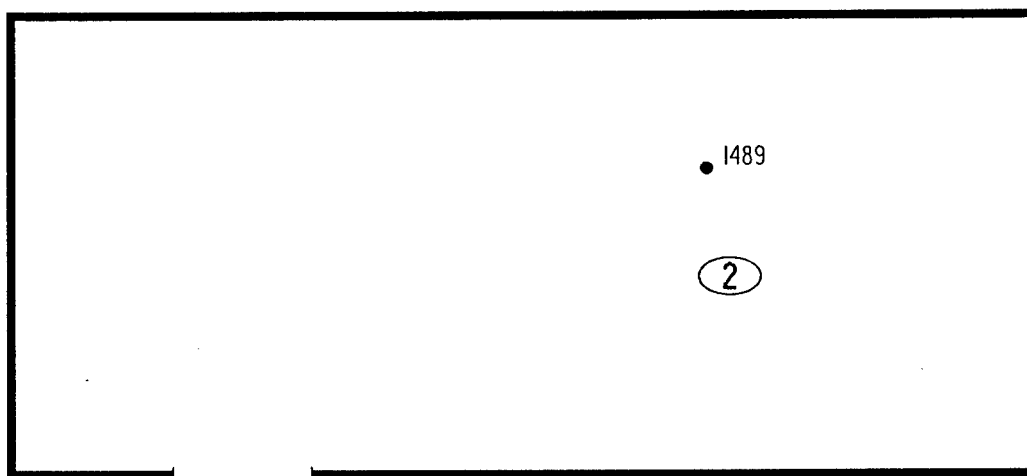
The condition of ACM was observed to be good and non-friable. These materials are not considered to be a significant environmental concern.

ASSUMED ASBESTOS ROOFING COMPONENTS

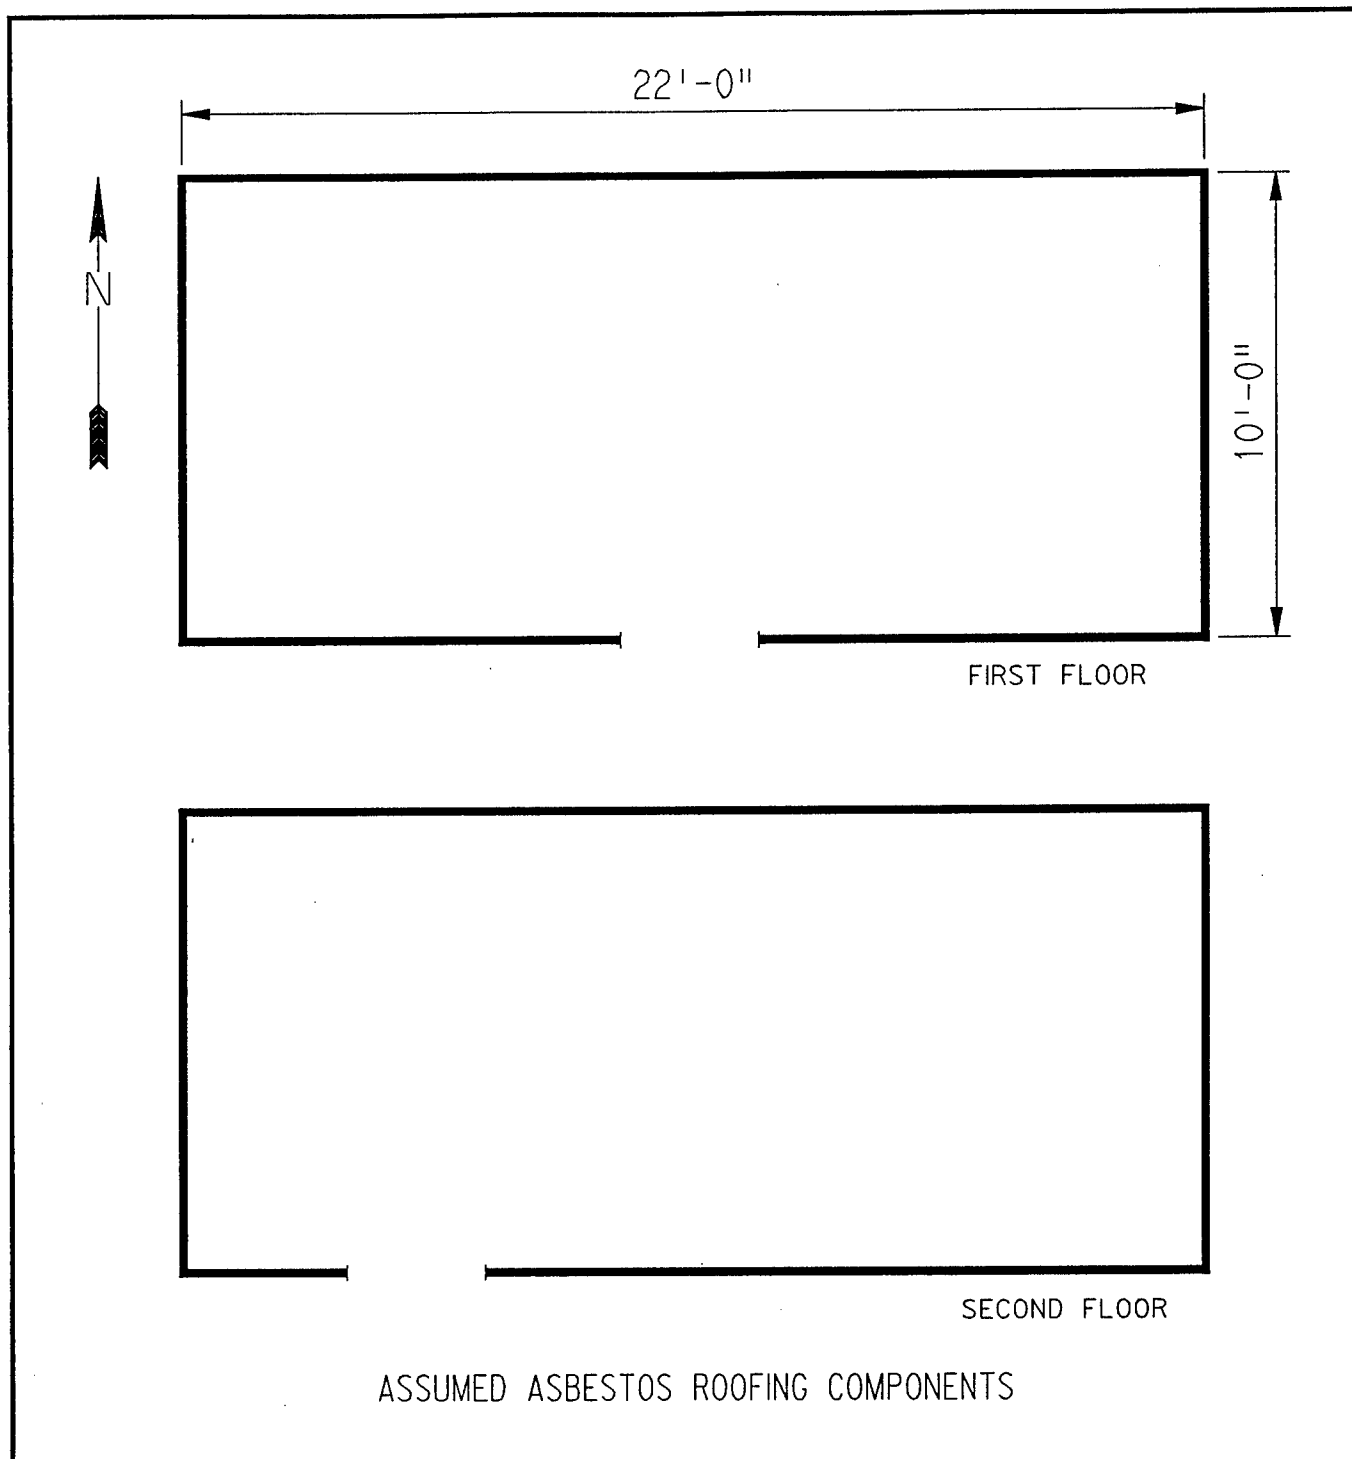
ACM was observed to be nonfriable and in good condition. This ACM is not considered to be a significant environmental concern.

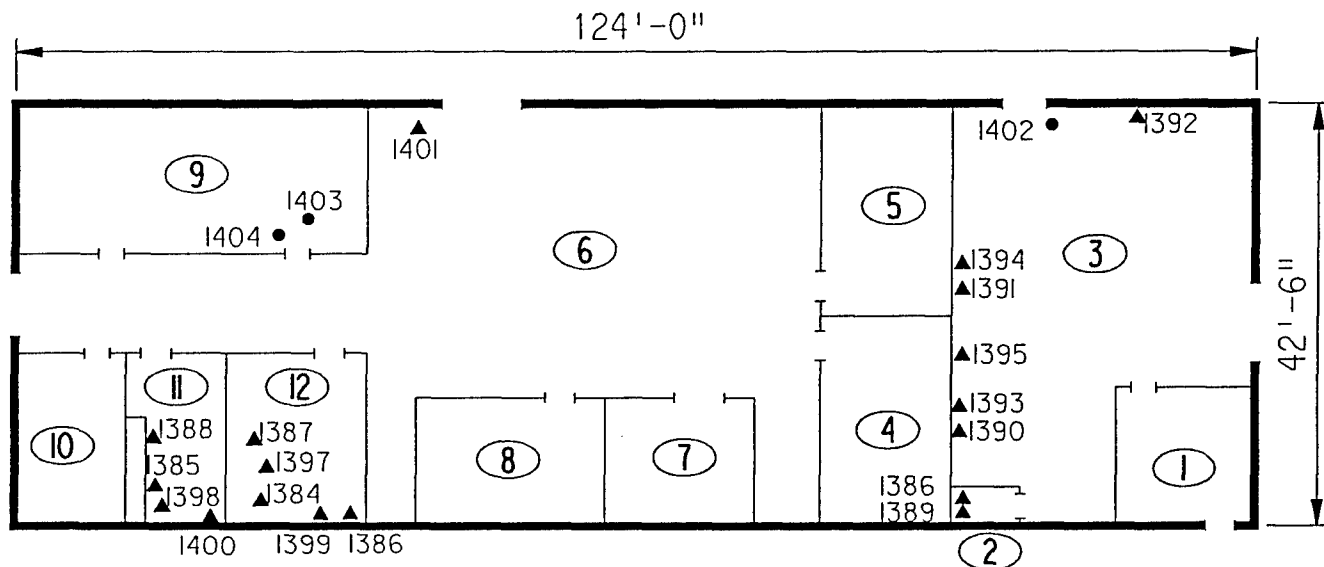
The general condition of ACM present was observed to be good with the noted exceptions above. Pipe insulations were observed to be friable, while other ACMs were nonfriable. The felt wrap insulation (PI-01) was sampled in three places, and all three samples showed no asbestos fibers. Thus, the felt wrap is not considered ACM in this building; however, most of the felt wrap insulation sampled at JPG was ACM, and felt wrap pipe insulation in Building 291 should be sampled prior to any removal or renovation. Other TSI in Building 291 shows signs of deterioration and should also be repaired or removed if the building usage changes.

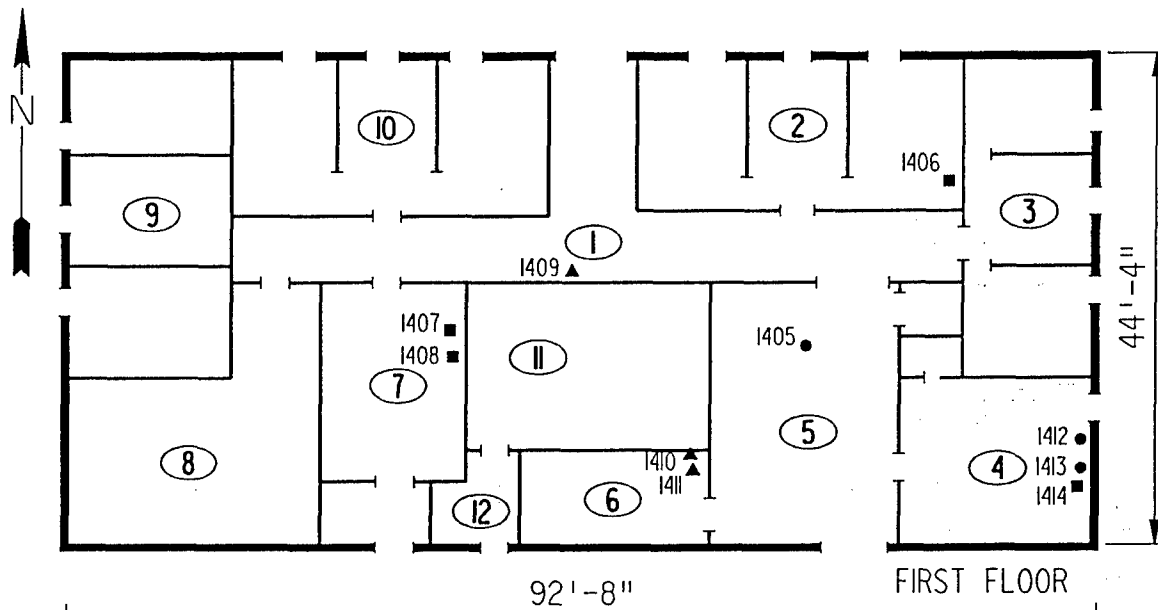
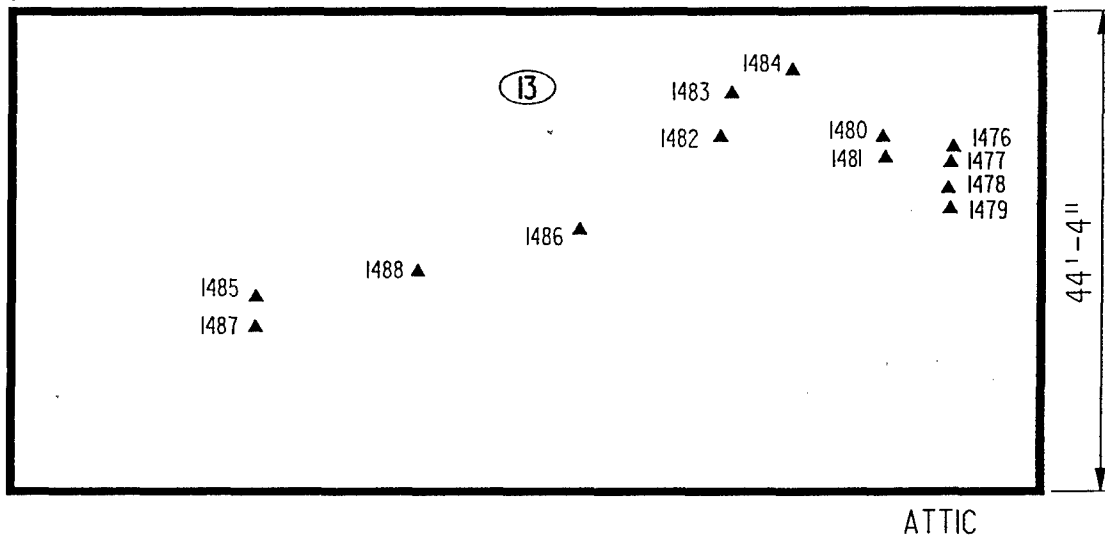
The general condition of ACM present was observed to be poor. ACM pipe and duct insulations were observed to be extremely friable and would need to be removed prior to any full-time utilization (including storage). In nearly every room, the pipes run to overhead heaters with attached fan units. If these units were to be restarted, there could potentially be large amounts of contamination blown throughout the building. At the time of the inspection, the building's heating system was not operational. The cement board floor panels were observed to be nonfriable, but were significantly damaged and should also be removed. The remaining ACM was observed to be nonfriable.

Access to the buildings interior area needs to be controlled through posting asbestos hazard warning signs at the doorways; instituting a work permit system; setting up work reviews and procedures; establishing personnel monitoring and personnel protective equipment requirements; and training all personnel accessing those areas.

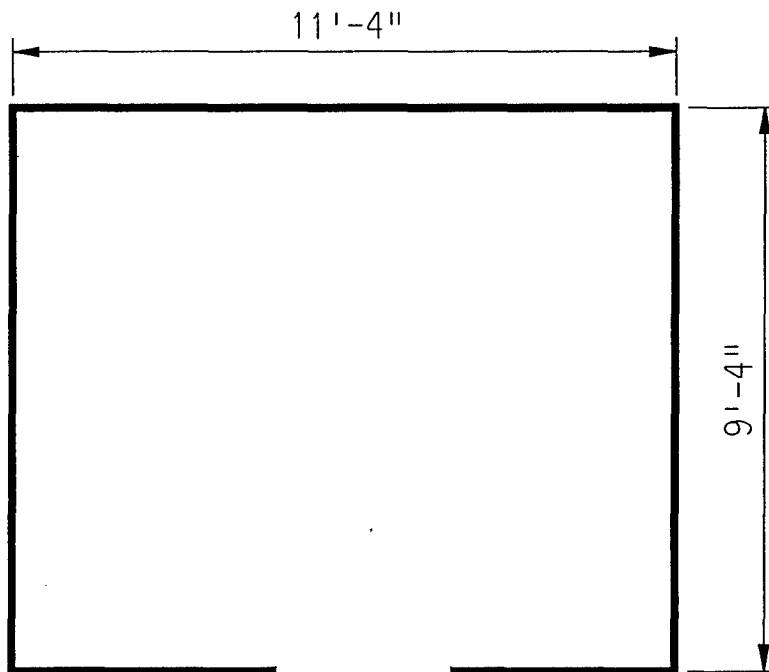
The general condition of ACM present was observed to be good with the noted exceptions above. ACM observed was nonfriable.

ASSUMED ASBESTOS ELECTRICAL PANEL INSULATION

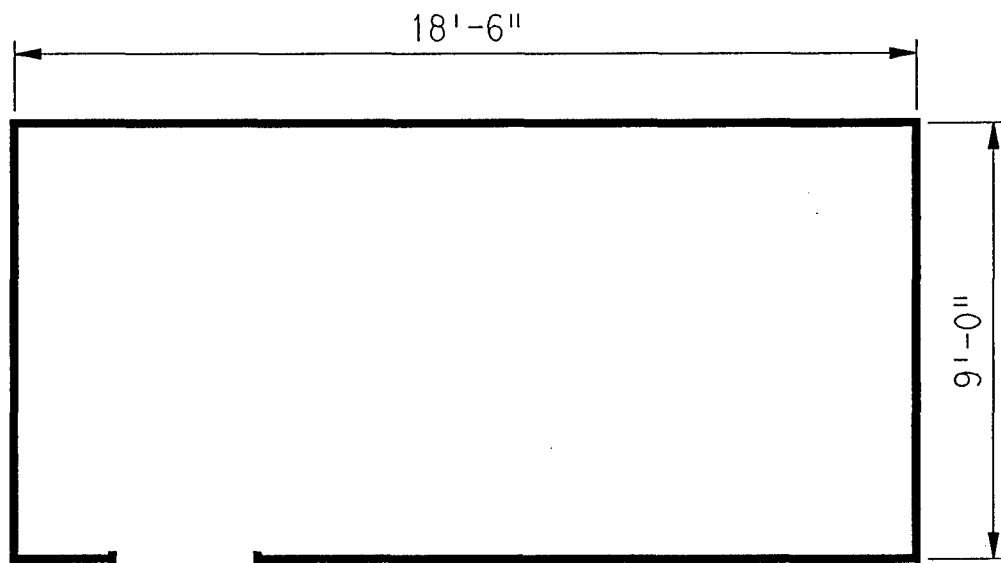
ACM was observed to be nonfriable and in good condition. This ACM is not considered to be a significant environmental concern.

ASSUMED ASBESTOS ROOFING COMPONENTS

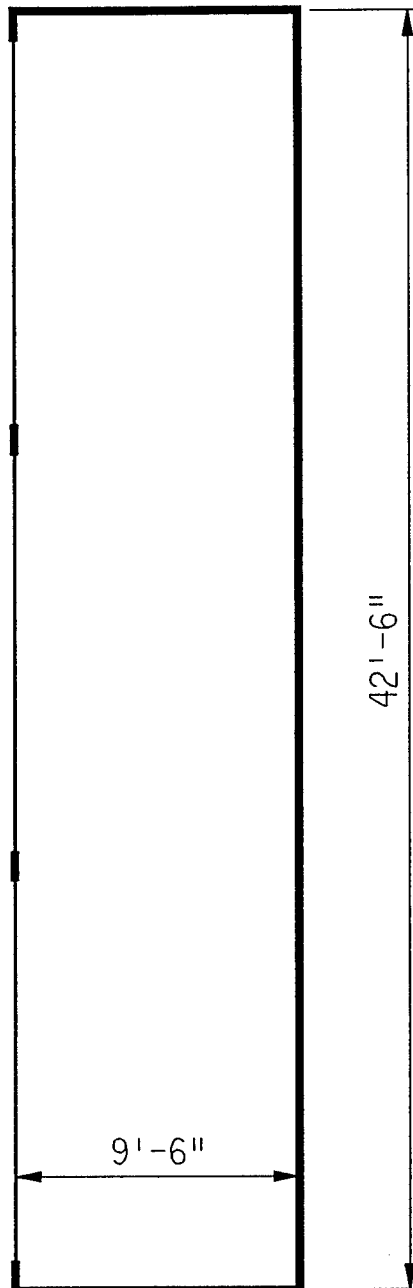
ACM was inaccessible for inspection. This ACM is typically nonfriable and not considered to be a significant environmental concern.

ASSUMED ASBESTOS ELECTRICAL INSULATORS

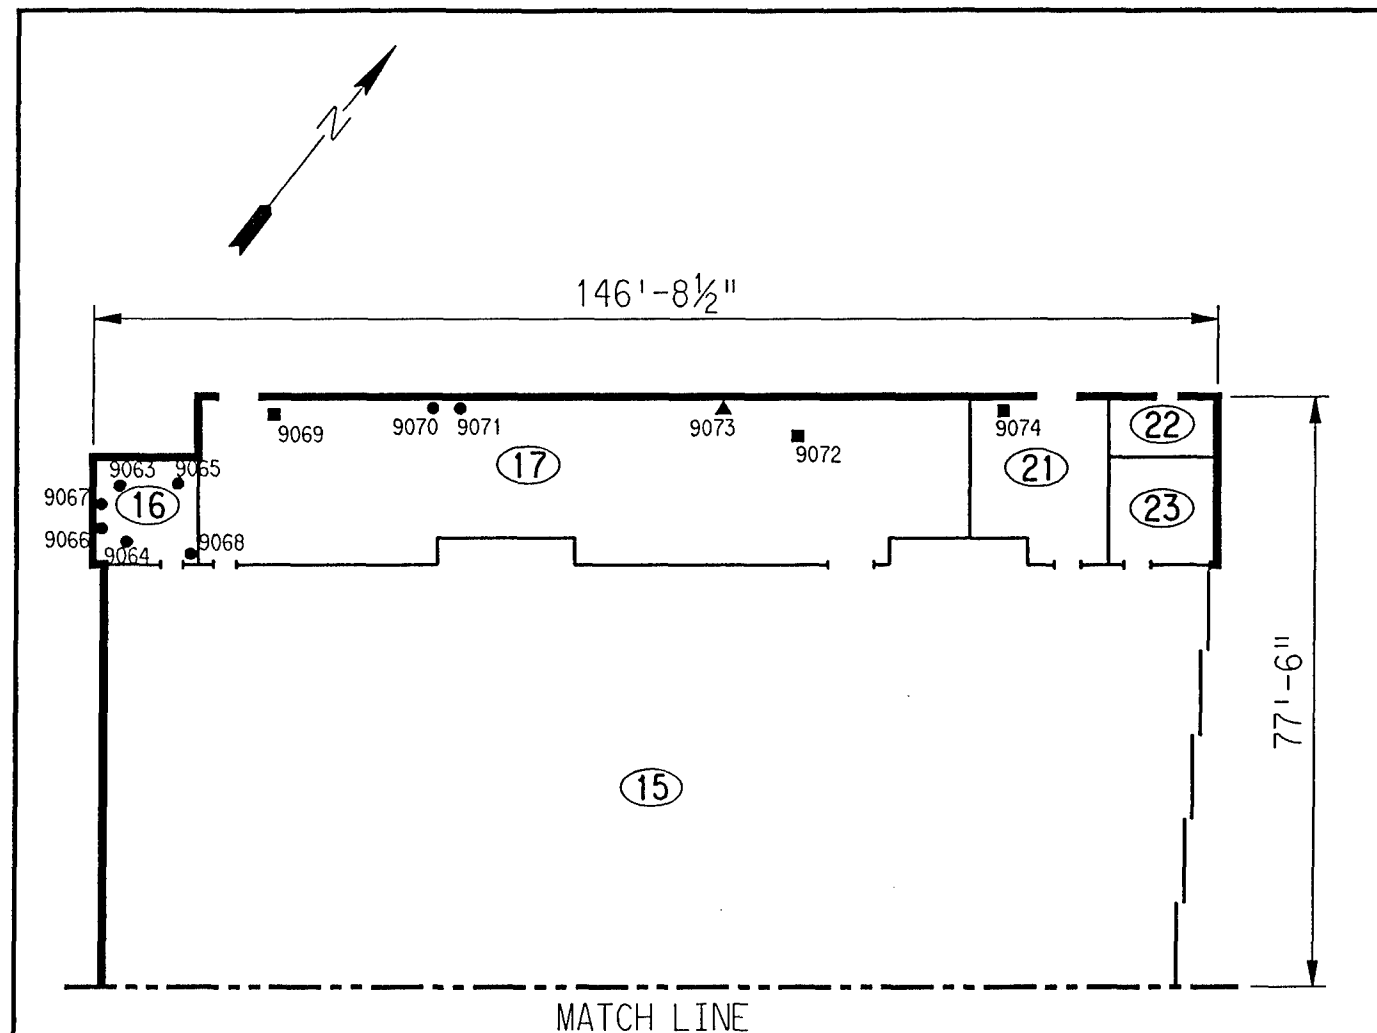
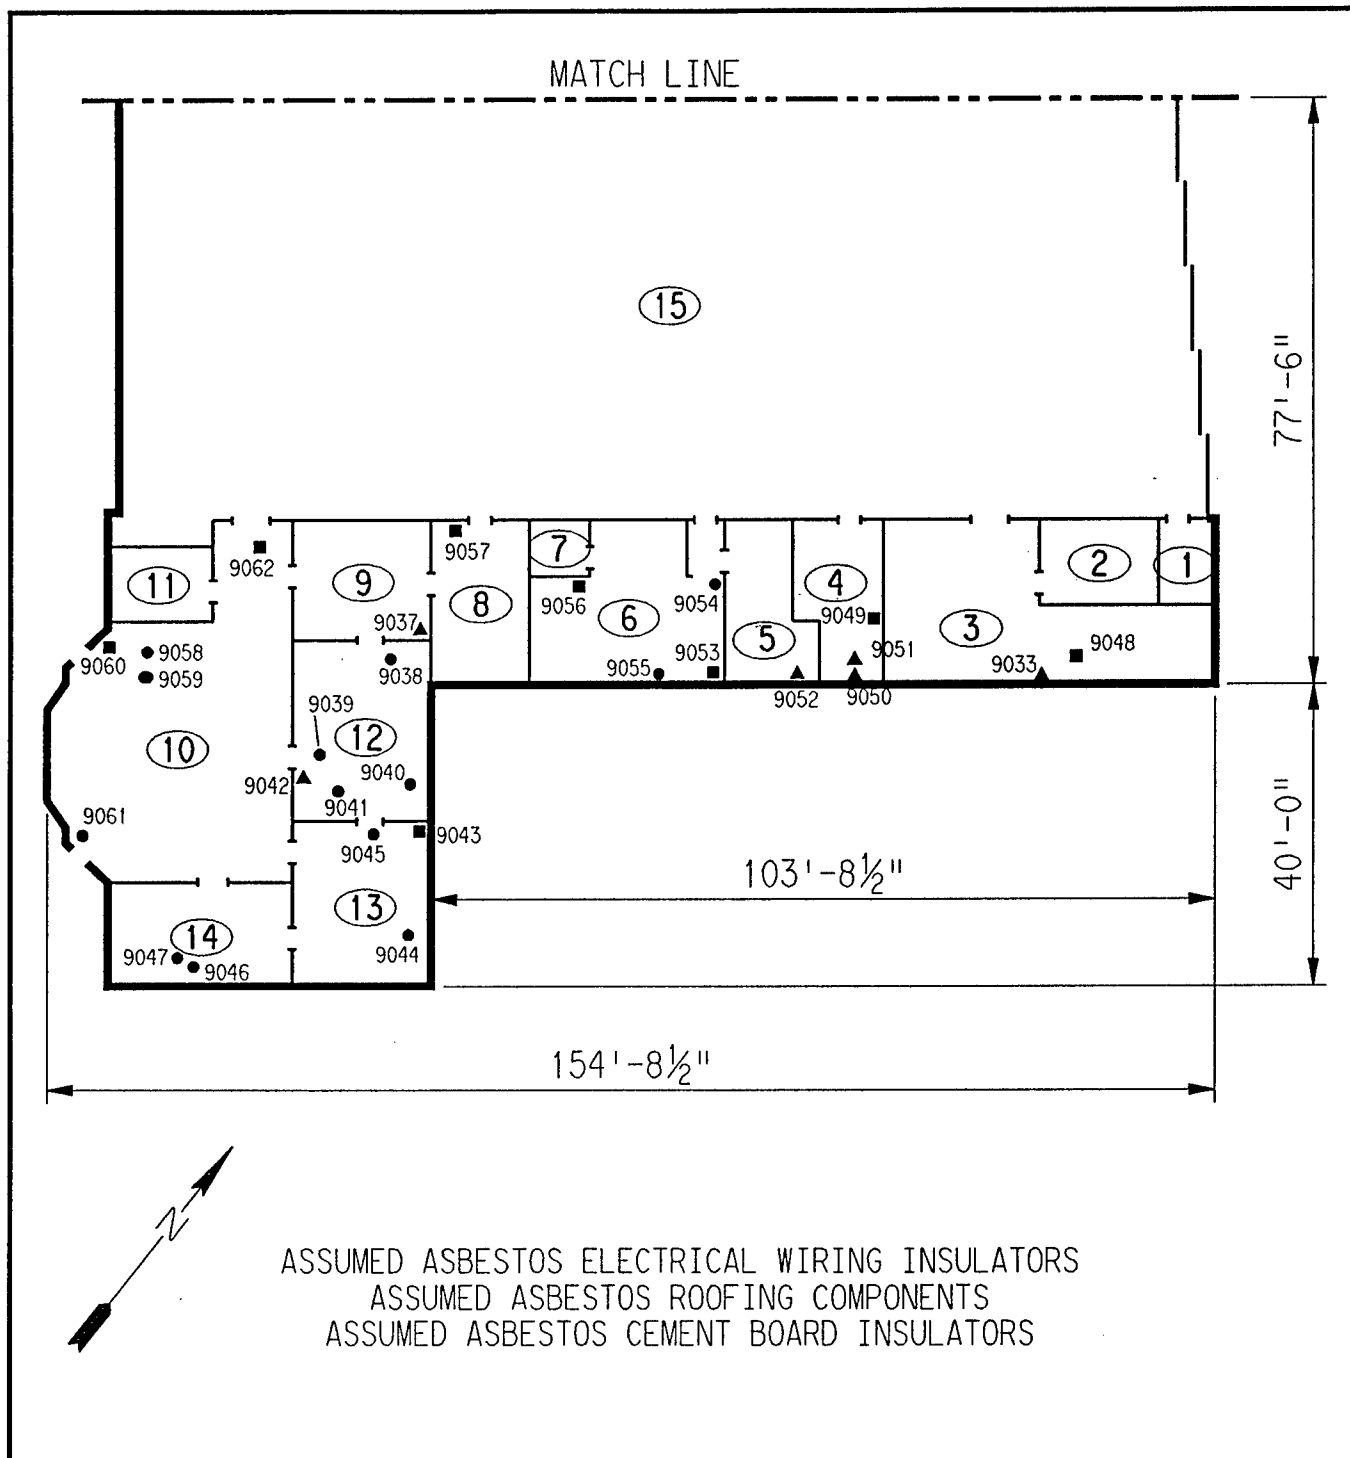
The general condition of ACM present was observed to be fair to poor with much evidence of general or significant physical damage or material deterioration. ACM pipe insulations were observed to be extremely friable. Other ACM were nonfriable because of the nature of their composition, but could easily become friable during routine physical contact because of their observed poor condition. As such, ACM should be removed prior to any reoccupancy of this facility.

ASSUMED ASBESTOS ELECTRICAL WIRING INSULATORS  
 ASSUMED ASBESTOS ROOFING COMPONENTS  
 ASSUMED ASBESTOS CEMENT BOARD INSULATORS

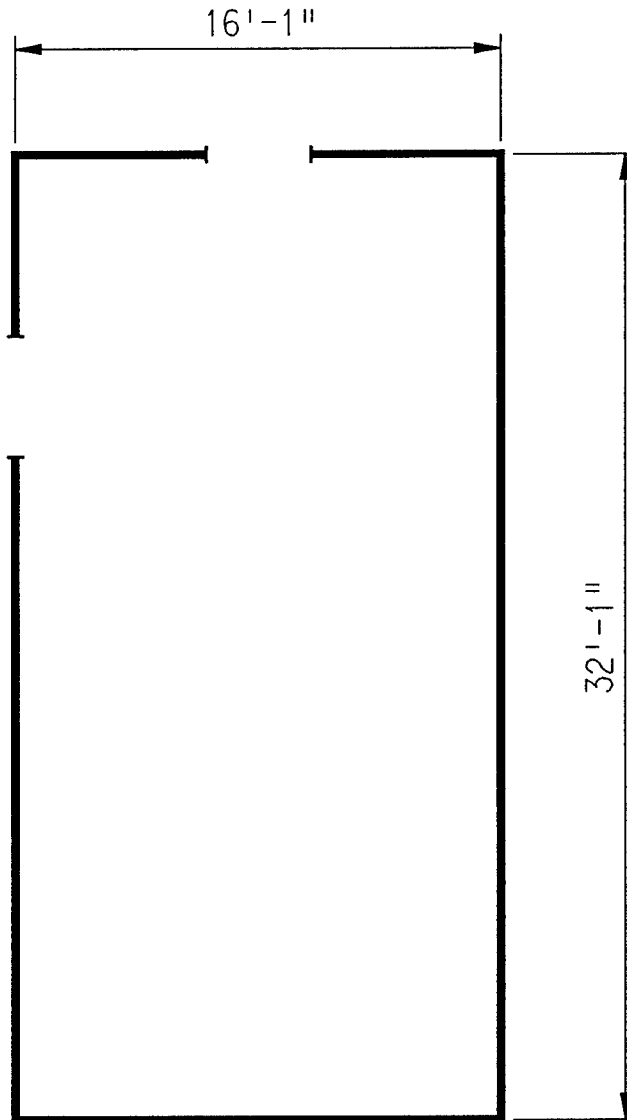
The general condition of ACM present was observed to be good with the noted exceptions above. ACM observed was nonfriable.

ASSUMED ASBESTOS ROOFING COMPONENTS  
ASSUMED ASBESTOS CEMENT BOARD TRANSFORMER INSULATORS

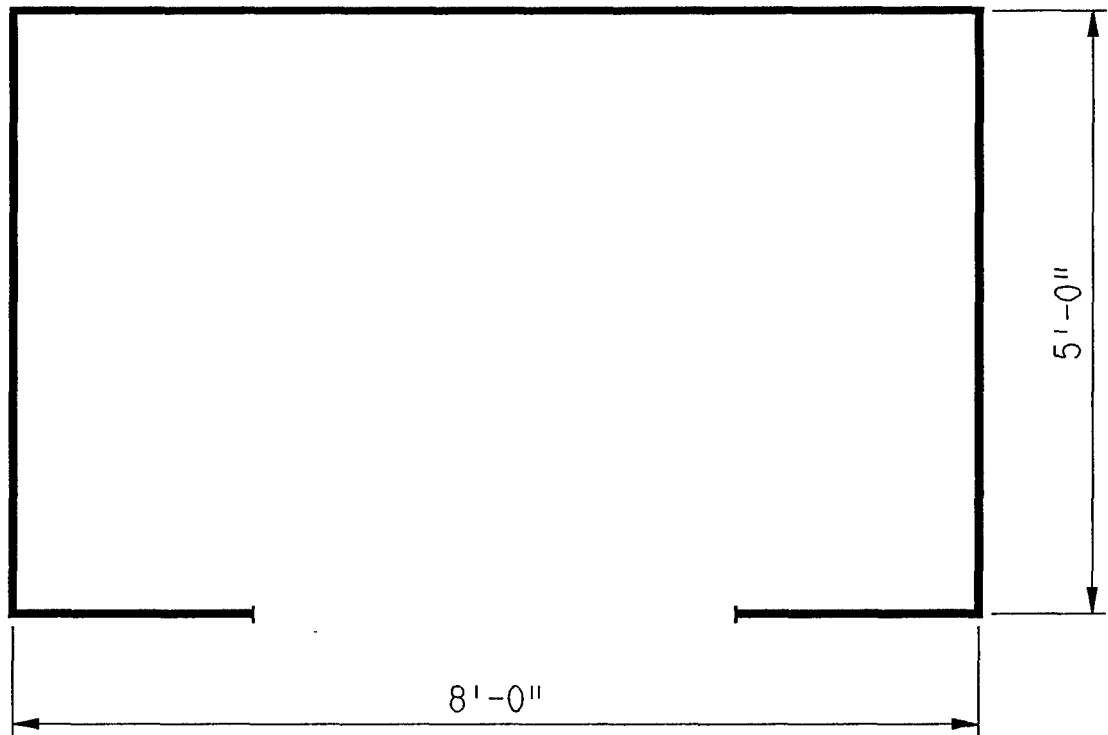
The general condition of ACM present was observed to be good with the noted exceptions above. ACM observed was nonfriable.

ASSUMED ASBESTOS ROOFING COMPONENTS

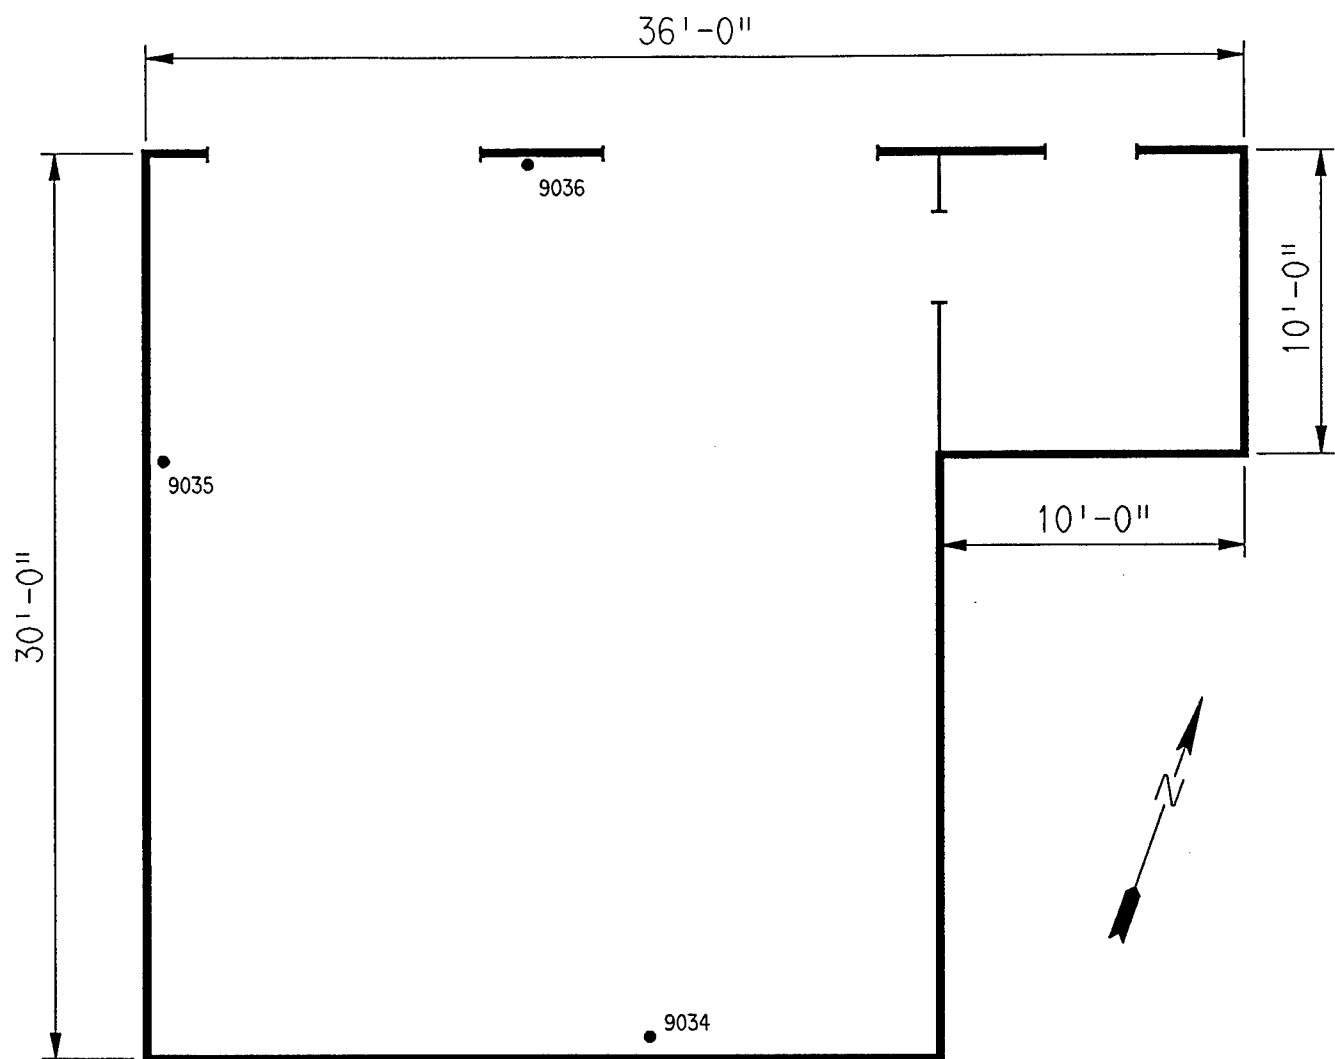
The general condition of ACM present was observed to be good with the noted exceptions above. ACM observed was nonfriable. The wallboard inside the building was sampled and was determined to be non-ACM.

# ASSUMED ASBESTOS ROOFING COMPONENTS

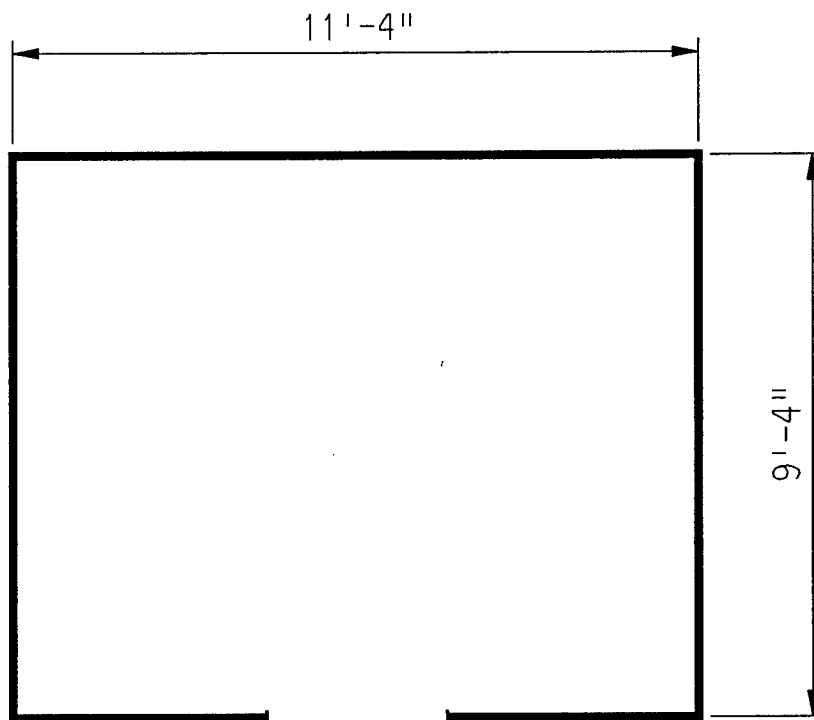
The general condition of ACM present was observed to be good with the noted exceptions above. ACM observed was nonfriable.

ASSUMED ASBESTOS ROOFING COMPONENTS  
ASSUMED ASBESTOS ELECTRICAL PANEL INSULATORS

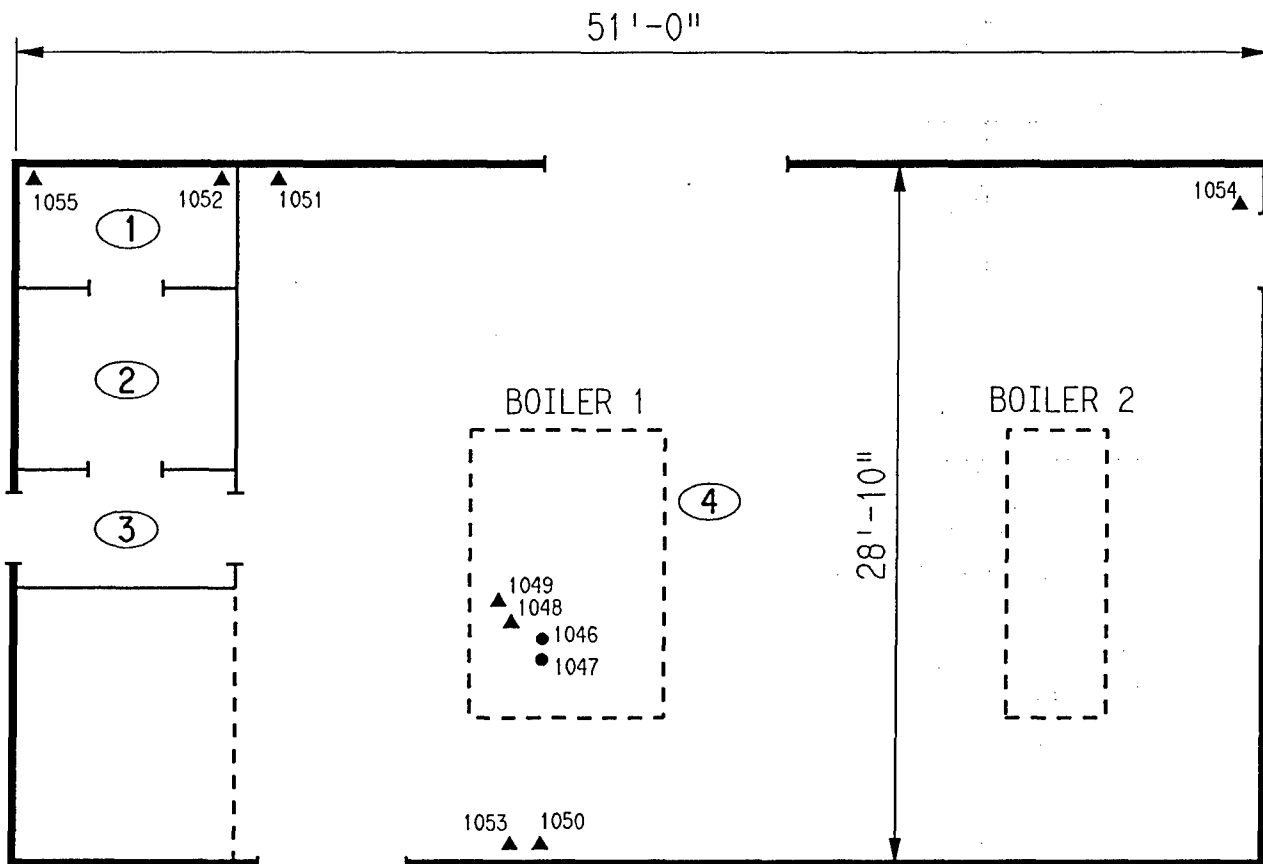
The general condition of ACM present was observed to be fair to good as noted above. ACM pipe insulations were observed to be extremely friable. Woven gasket materials were also friable. The remaining ACM was observed to be nonfriable.

SUSPECTED ASBESTOS ROOFING COMPONENTS

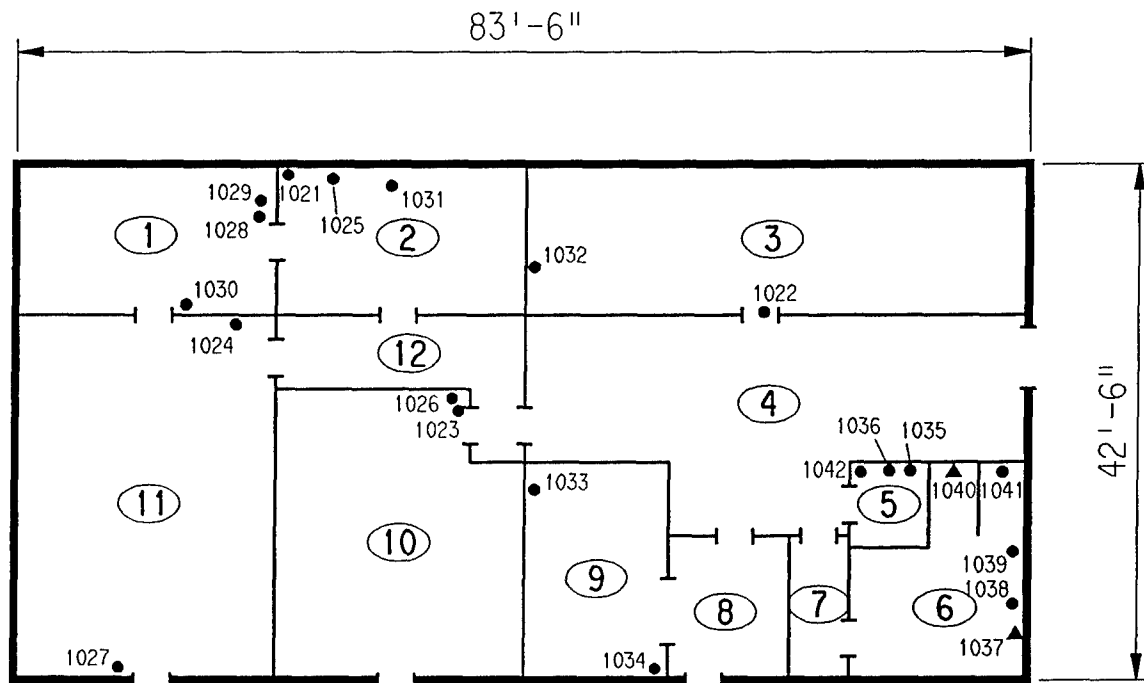
ATTIC - ROOM (13)  
SAMPLE Nos. 1018, 1019, 1020

The condition of ACM present was observed to be good. Pipe insulations were observed to be friable, while other ACMs were nonfriable. The blown-in insulation in the attic was sampled and determined not to contain asbestos.

ASSUMED ASBESTOS ROOFING COMPONENTS  
ASSUMED ASBESTOS EXPANSION JOINT

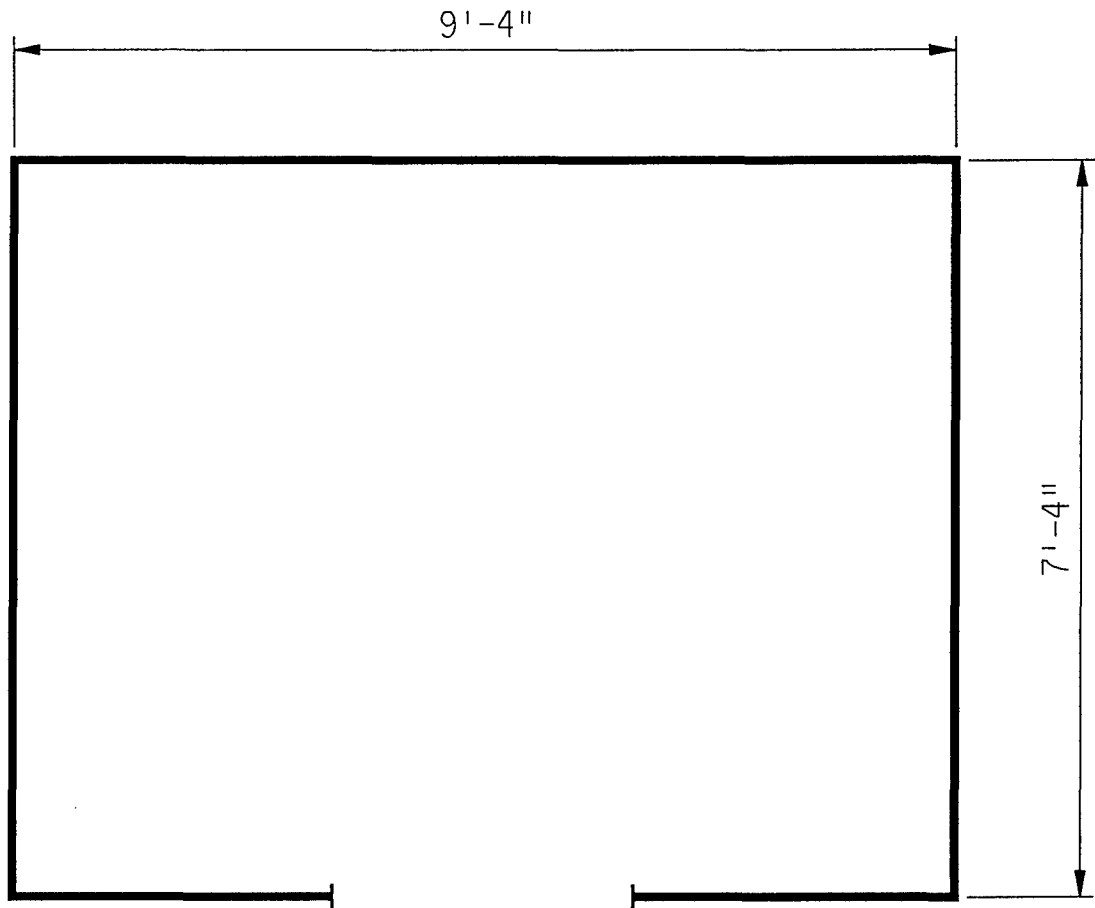
The general condition of ACM present was observed to be good with the noted exceptions above. ACM observed was nonfriable.

ASSUMED ASBESTOS ROOFING COMPONENTS  
ASSUMED ASBESTOS ELECTRICAL PANEL INSULATORS
